The Kona Earthquake of August 21, 1951, and Its Aftershocks¹

GORDON A. MACDONALD and CHESTER K. WENTWORTH²

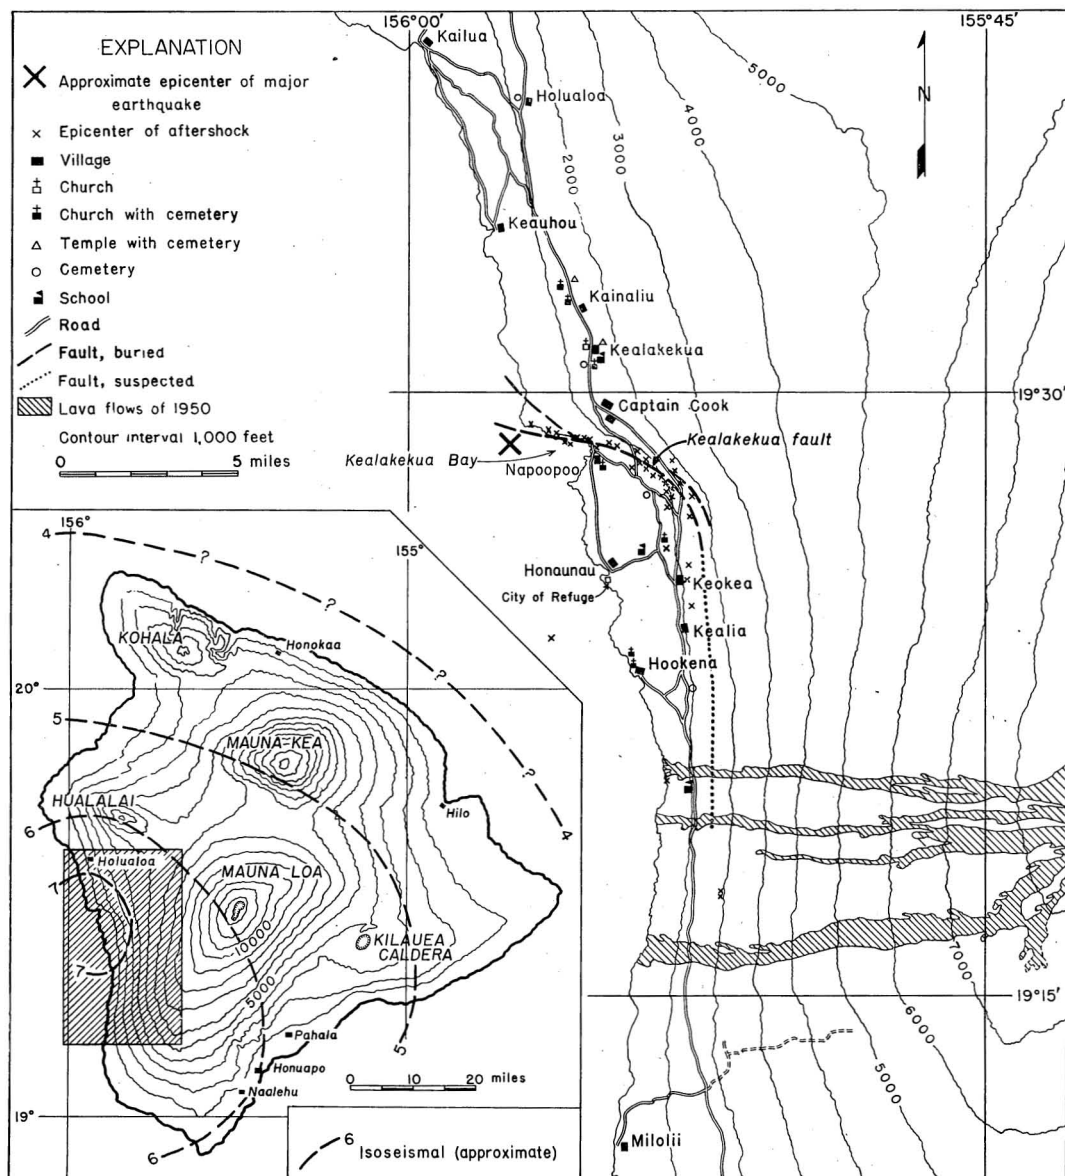
FIG. 1. Map of the central Kona district showing the location of places mentioned in the text and the approximate locations of the epicenters of the major earthquake of August 21, 1951, and of the aftershocks for which reasonably good locations were obtained. The inset map of the island of Hawaii shows the location of the area (shaded) covered by the other map and the approximate position of the isoseismal lines for the major earthquake.

Locations of the epicenters of aftershocks which occurred after 15:15 on August 23 with serial number greater than 190 are shown in Figure 1. Thirty-three such aftershocks have been located with small probable error. Most of them fall on or close to a fault that runs out to sea in a west-northwesterly direction along the northern edge of Kealakekua Bay. The existence of this fault, partly buried by later lava flows, has been recognized for many years (Dana, 1890: 30; Stearns and Macdonald, 1946: 37, pl. 1). At its eastern end it bends southward, and the writers have suspected that the abnormally steep lower western slope of Mauna Loa inland from the highway for 15 miles or more south of Captain Cook is a fault scarp deeply buried by later lava flows. An interesting partial confirmation of this theory is furnished by the location of the epicenters of several aftershocks along this line (Fig. 1).

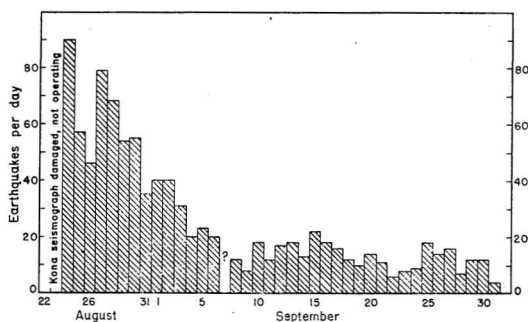
The frequency of aftershocks decreased rapidly from August 23 to September 4. As is shown in Figure 2, the average frequency then decreased very slowly until the end of September. No figure is available for September 7 because of mechanical failure in the recorder at the Kealakekua station. The apparent depth of origin of the aftershocks ranged from 3 to 12 miles, most being about 6 or 7 miles. No progressive change of depth with passage of time is apparent.

FIG. 2. Graph showing frequency of aftershocks to the end of September, 1951.

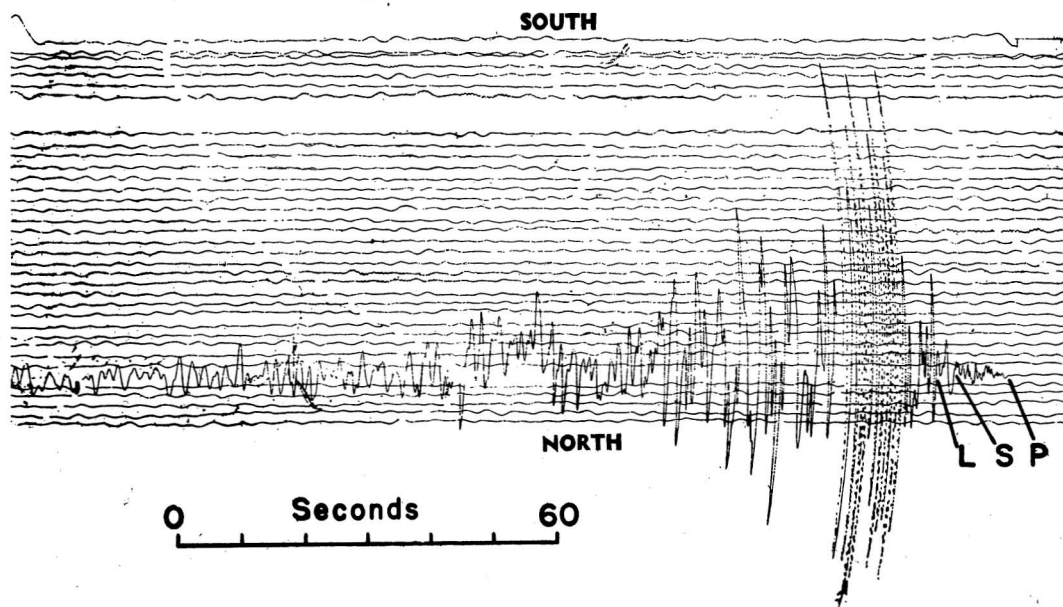
FIG. 13. Seismogram of aftershock recorded at 18:32, August 21, on the Bosch-Omori seismograph at Kilauea. Letters indicate the points of arrival of primary (P), secondary (S), and long (L) waves. The amplitude of 80 mm. on the seismogram corresponds to approximately 0.7 mm. of ground motion at Kilauea, 47 miles from the epicenter.
